A Case Report on the Effective Usage of Helicoll Skin Substitute with Negative-Pressure Wound Therapy (NPWT) in the Treatment of Full Thickness Wound.

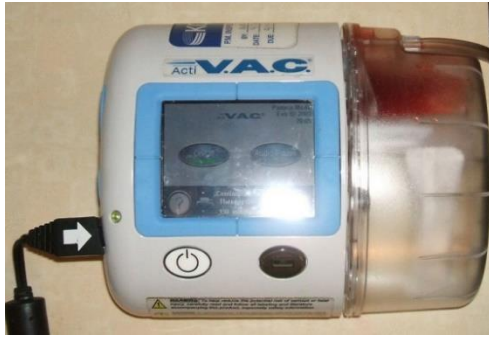
Fig 1: Pump used to create Negative

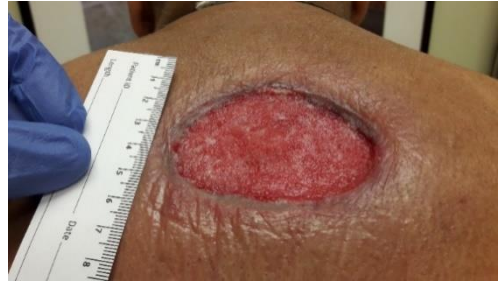
Fig 2: Wed 5th July 2017 - two days before Helicoll application the depth was significant

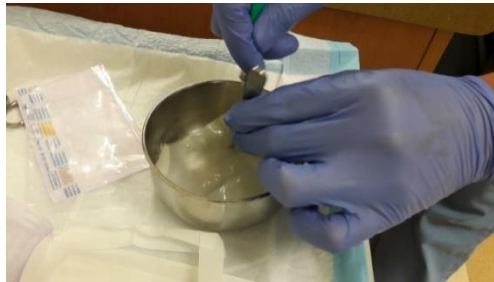
Fig 3: Fri 7th July 2017 - Helicoll Preparation prior to application – made 1 cm slit openings, 1 cm apart using a sterile scalpel

- 1: Prior to using the Wound Vac, Helicoll was soaked in normal saline for 5 to 10 min and using a sterile scalpel blade or using a fine tipped scissors, incisions of approximately 0.5 cm long with 1 cm distance was made throughout the membrane.
- 2: Helicoll was applied over the debrided wound and then the excess areas of membrane were removed using sterile scissors. To aid the transport of fluids, slit openings may be made in the collagen membrane prior to applying on to the wound directly.
- 3: An Adaptic (non-adherent porous dressing) was applied and all the excess overflowing areas over the wound were trimmed.
- 4: The routine application of the sponge and other application procedure of the Wound Vac were followed.

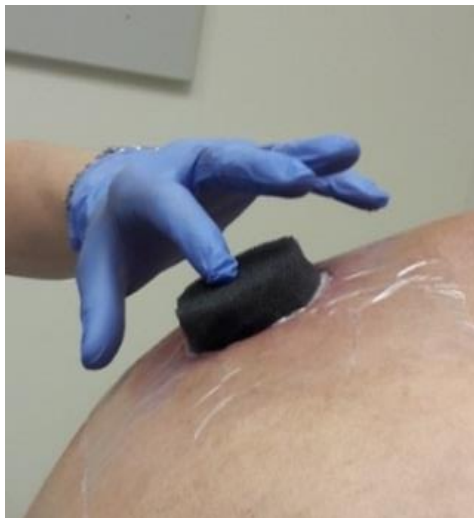
Fig 4: Application of sponge at the suction site over the wound before connecting the tubing and sealing

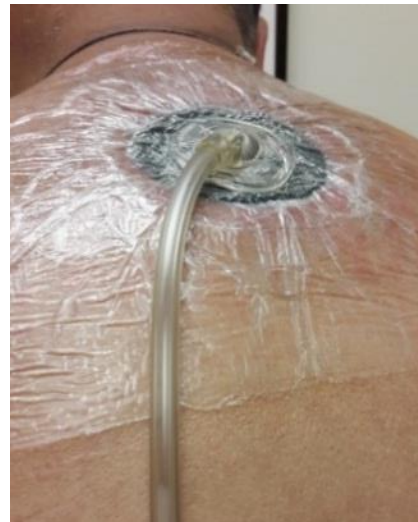
Fig 5: Wound Vac in full function with sealed sponge

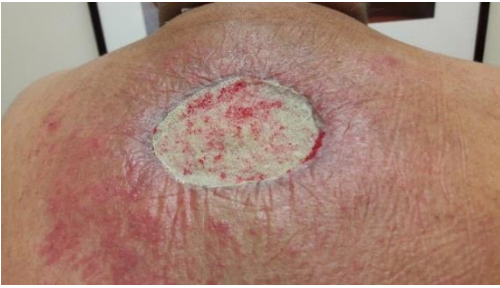
Fig 6: Wed 12th July 2017 - 5th day after removing secondary dressing leaving adaptic and Helicoll intact. Shows remarkable vascularization and granulation evidencing faster healing

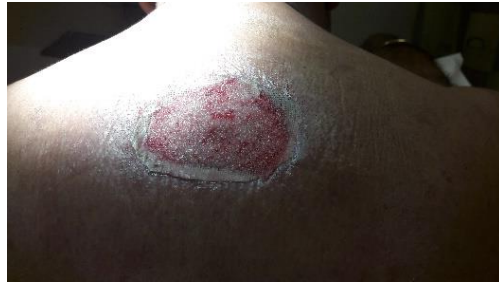
Fig 7: Fri 14th July 2017 – Just prior to the 2nd application of Helicoll after removing the black sponge, Adaptic and remnants of Helicoll.

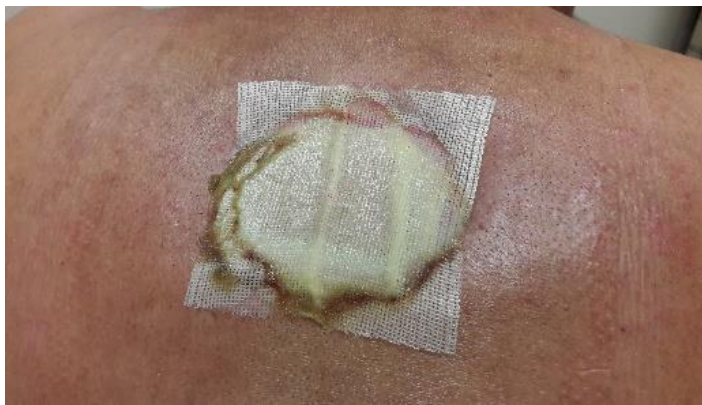
Fig 8: Mon 17th July 2017, 3rd day after the 2nd & final application of Helicoll resulting in complete wound healing

- a. significant reduction of exudation in two days,
- b. the cell debris outflow is reduced and it is evidenced by the reduction of redness in the fluids on the second day of application
- c. the full-thickness wound depth reduction was significant on 45th day after Helicoll application
